LPC 1971100002-Will
CELOTEX
ILD 981961634
SF/HRS

Site Inspection

Prioritization

Report

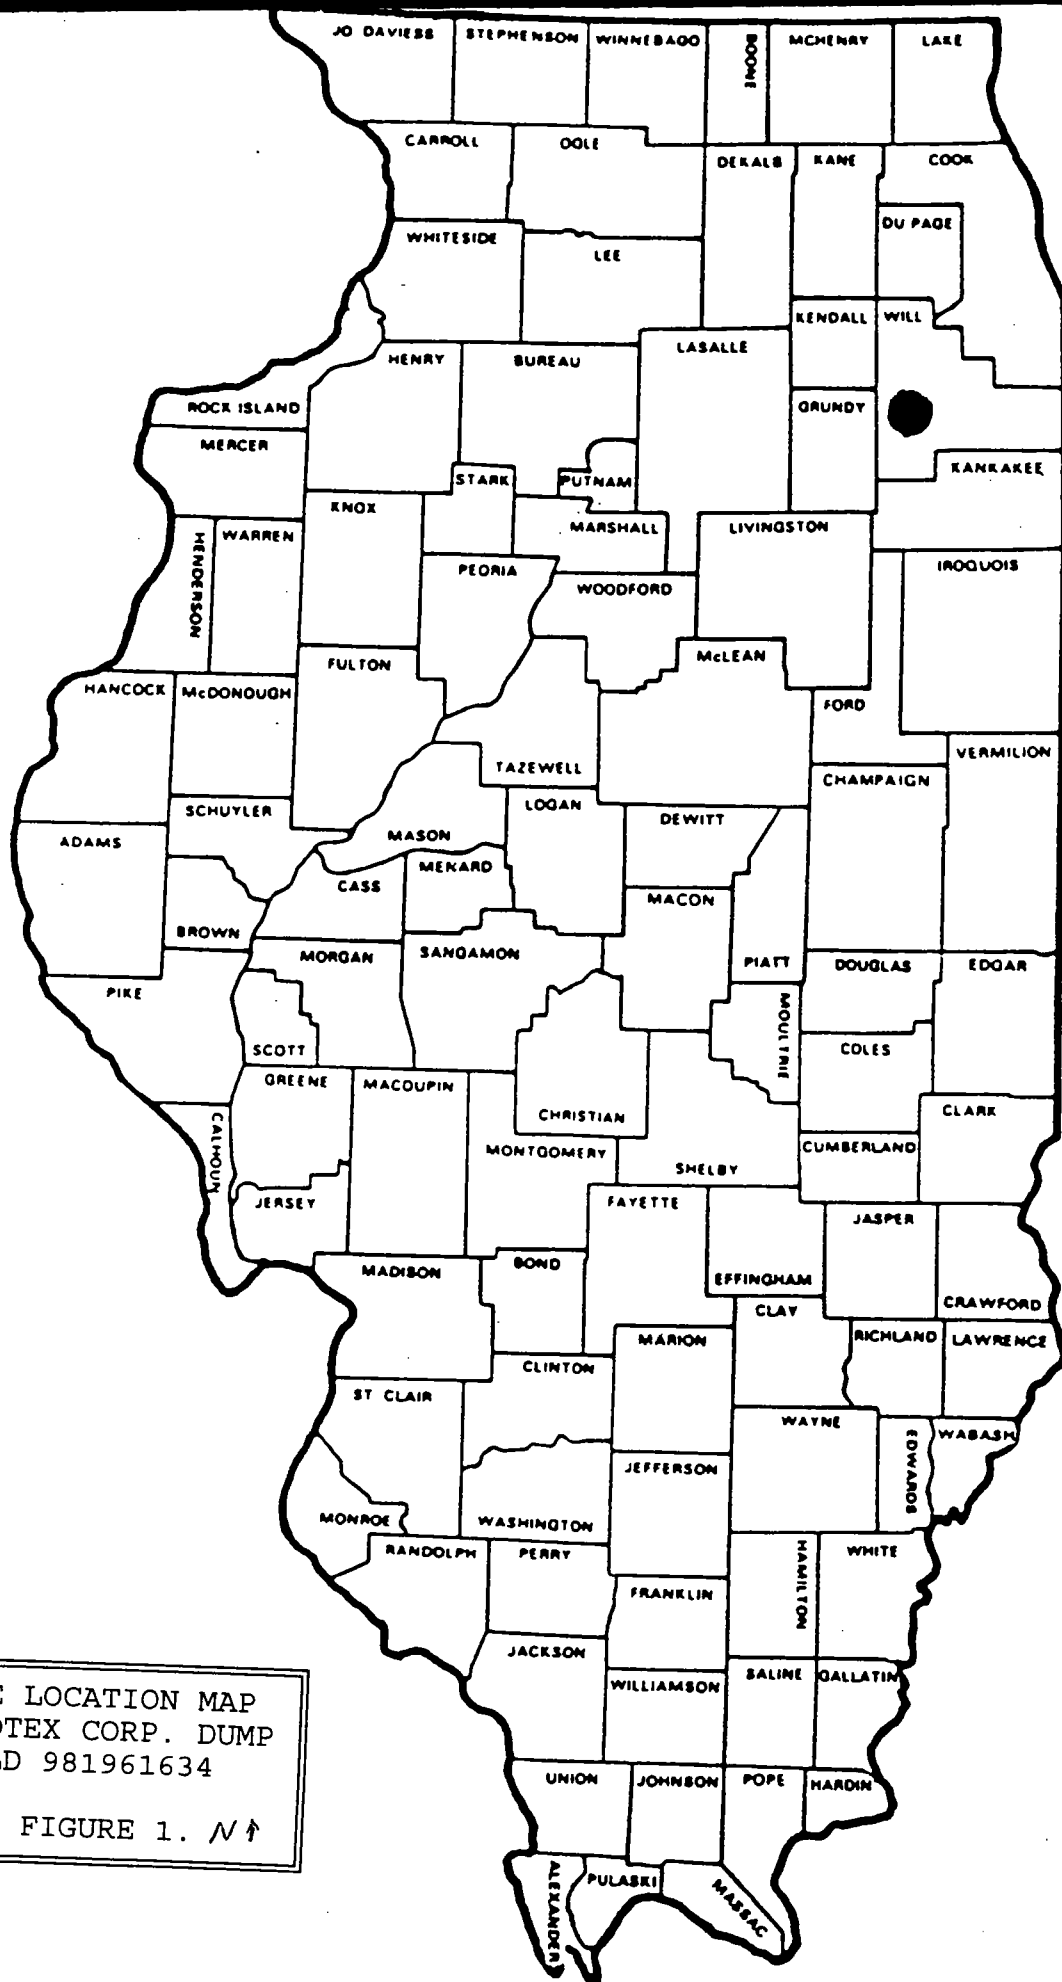
FIGURE 1. N ↑

SITE LOCATION MAP
CELOTEX CORP. DUMP
ILD 981961634

The Site is located just east of the Kankakee River on Kankakee Street in Wilmington, Illinois. Celotex operated a solid waste disposal site on a 40 acre parcel of land located at the Northwest 1/4 of the Northwest 1/4 of Section 25, Township 33 North, Range 2 East, in Will County. This disposal area consists of two landfills, two surface depressions, and several unlined disposal lagoons. The landfills appear to be inactive, partially covered and vegetated. The lagoons contain three to four feet of clear water and lack emergent and surficial animal and plant life. This entire area is prone to flooding from the Kankakee River on the west and from the Forked Creek to the south. The perimeter of the site has three distinct wetland areas, one to the northeast, one to the south, and one to the southwest. The site is bordered on the northeast and east by residential areas. These residential areas provide several points of access to the site. Man made paths and trails are easily found throughout this area, showing some possible recreational uses of the site. (See Figure 1, Site Location Map and Figure 2, Site Topographic Map.)

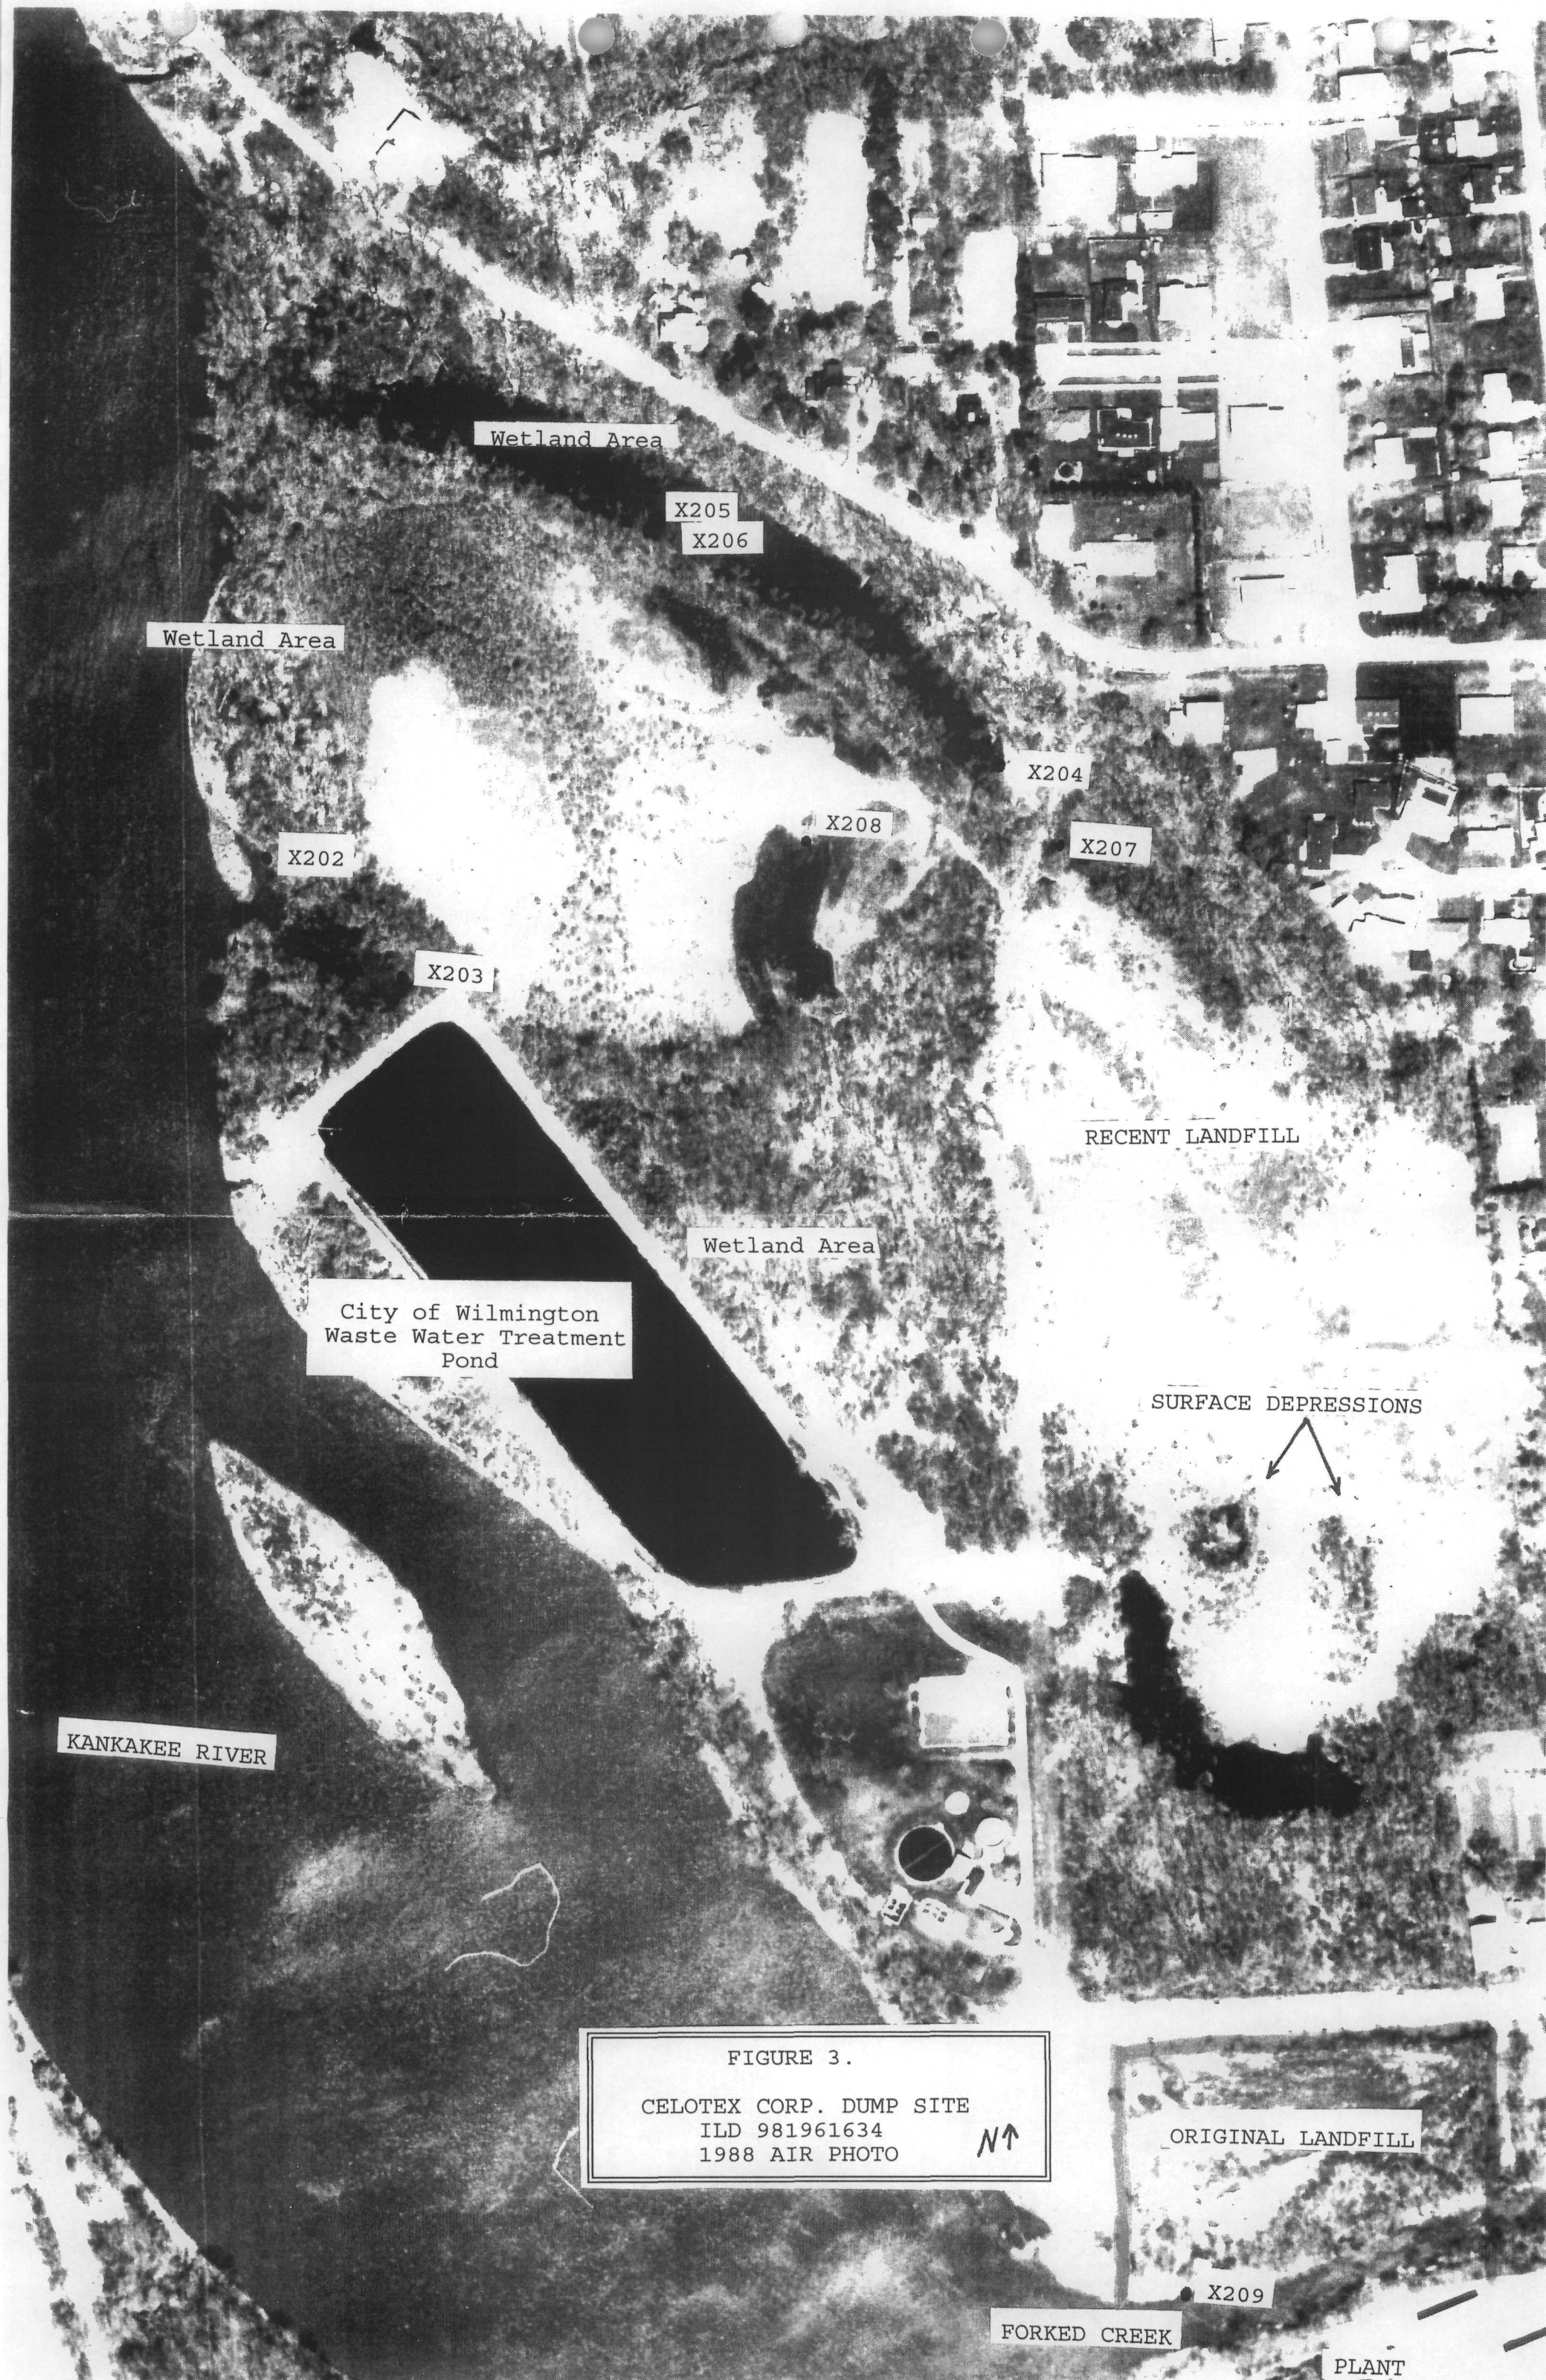
FIGURE 3.

CELOTEX CORP. DUMP SITE
ILD 981961634
1988 AIR PHOTO

ORIGINAL LANDFILL

X209

FORKED CREEK

PLANT

The CERCLA Site Inspection Prioritization field sampling activities took place on June 15, 1995. A total of 10 sediment samples were collected during the SIP from the Forked Creek, Kan~~o~~kee River, on-site surface impoundment, and on-site wetland areas. Samples were collected using stainless steel trowels and augers. All sampling was performed in accordance with IEPA sampling methods and procedures. The sediment samples were taken to determine if contaminants were present at the facility and if they had migrated from the property. Figure 3 identifies the sample locations from the May 1995 SIP. Sample descriptions are summarized in Table 1.

The landfill was identified in aerial photographs and in a 1989, Screening Site Inspection Report. This area is approximately 22 acres in size and was not an engineered disposal area. This area was utilized after a smaller landfill located to the south was filled to capacity. Runoff from this area collects in two wetlands that each empty into the Kankakee River. Inorganics, mainly copper have been detected along both of these surface water paths. In Figure 3. it is referred to as the recent landfill.
